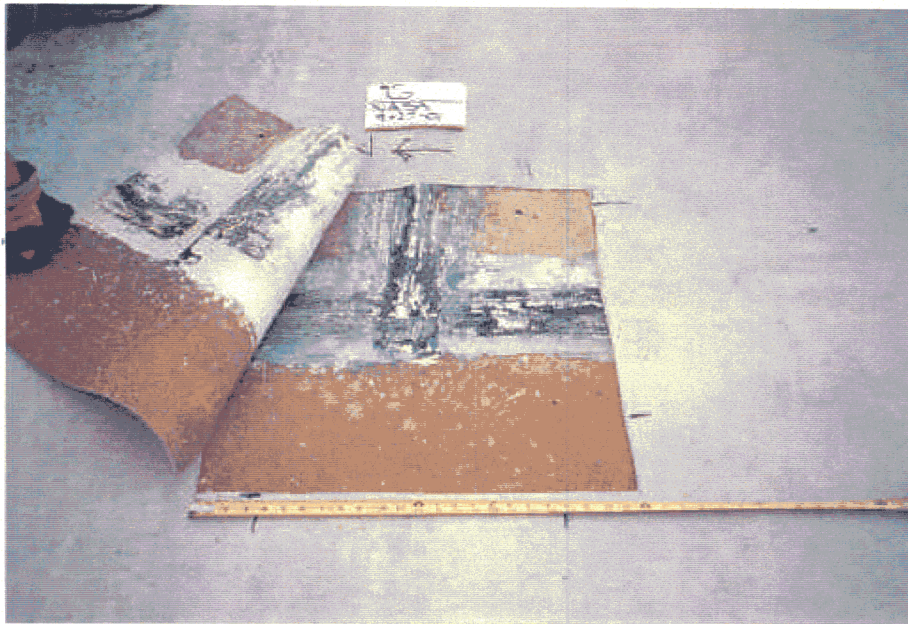
Figure 2.6-25 Inspection Opening No. 6

- g. Approximately 1-1/2 -inch thick layer of composite bitumen-aggregate fill (wet).
- h. Concrete roof slab.
